Journal of Asian Scientific Research

FAILURE ANALYSIS OF A FRACTURED CONNECTING ROD

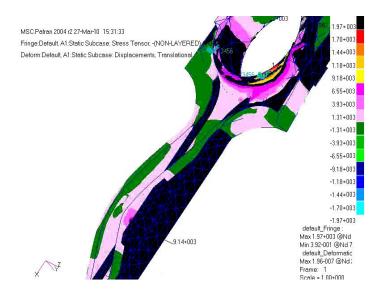
Fig-3. The Von Misses stresses in compressive loading of the connecting rod

Based on the results obtained from analyzing the finite element, it can be noticed that the connecting rod subjected into diverse loads led to some deformation during the compression and power stroke. The results also revealed that there is a repetition of the loading with every crankshaft revolution, so this means that it supported the fatigue load. Due to this loading, each casting defect is potential to develop itself as the initial point for fatigue-crack initiation.
