ANALYSIS OF SOIL TEXTURE, FURROW GEOMETRY AND INFILTRATION RATE FOR IMPROVING WATER APPLICATION EFFICIENCY

DOI: 10.18488/journal.ajard.2021.111.19.27

To fill this knowledge gap, the present study was carried out on the Melka Hida surface irrigation scheme, constructed in 1999 by the government. It has an irrigation potential of 80 ha, and around 200 households are currently benefiting from it. Despite deterioration in its biophysical appearance, no evaluation of water application efficiency has been carried out to identify constraints and improve efficiency. Hence, it was deemed necessary to evaluate water application efficiency and devise the required improvements. The Melka Hida small-scale irrigation system is located in the Oromia Regional State of Ethiopia, West Guji Administrative Zone.

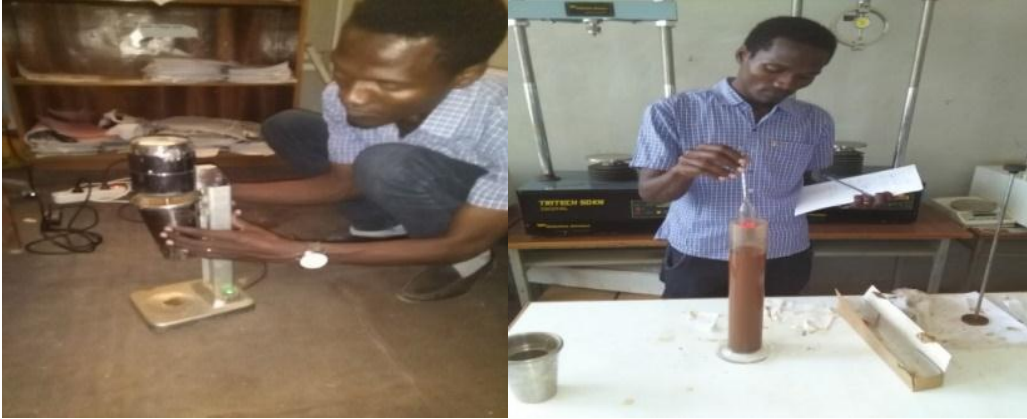
Figure 3. Laboratory test of soil samples.

In the laboratory, hydrometry was used to determine soil particle distribution while the USDA SCS soil textural triangle method was used to establish soil textural classification. The laboratory testing procedure on soil samples is presented in Figure 3. Bulk density of the soil was computed using Equation 1:

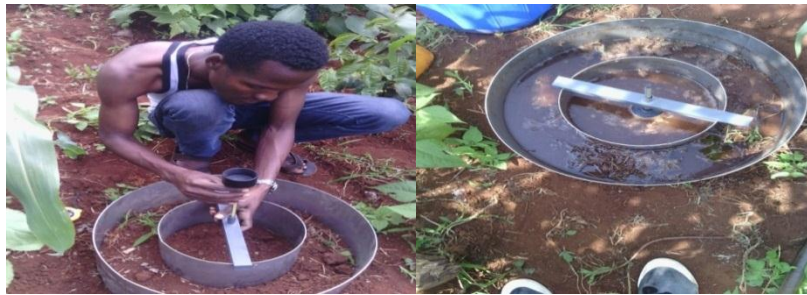
Figure 4. Measurement of soil infiltration rate.

Soil infiltration rate was determined in the field using a double-ring infiltrometer (Figure 4).

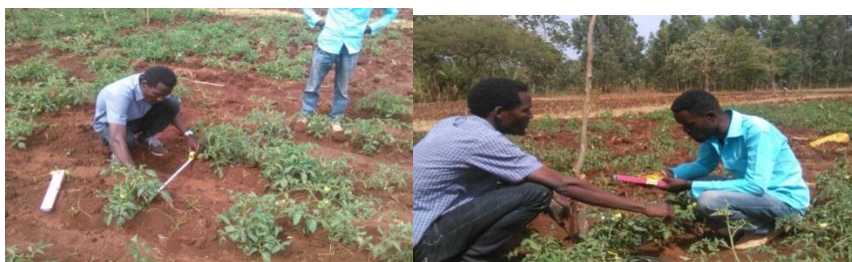
Figure 5. Measurement of slope and furrow dimensions in the field.

In this study, furrow length, width, depth, and spacing were measured for each replicate at all three farm plots using measuring tape, spirit level, ropes, and stakes (Kulapongse, 1966).

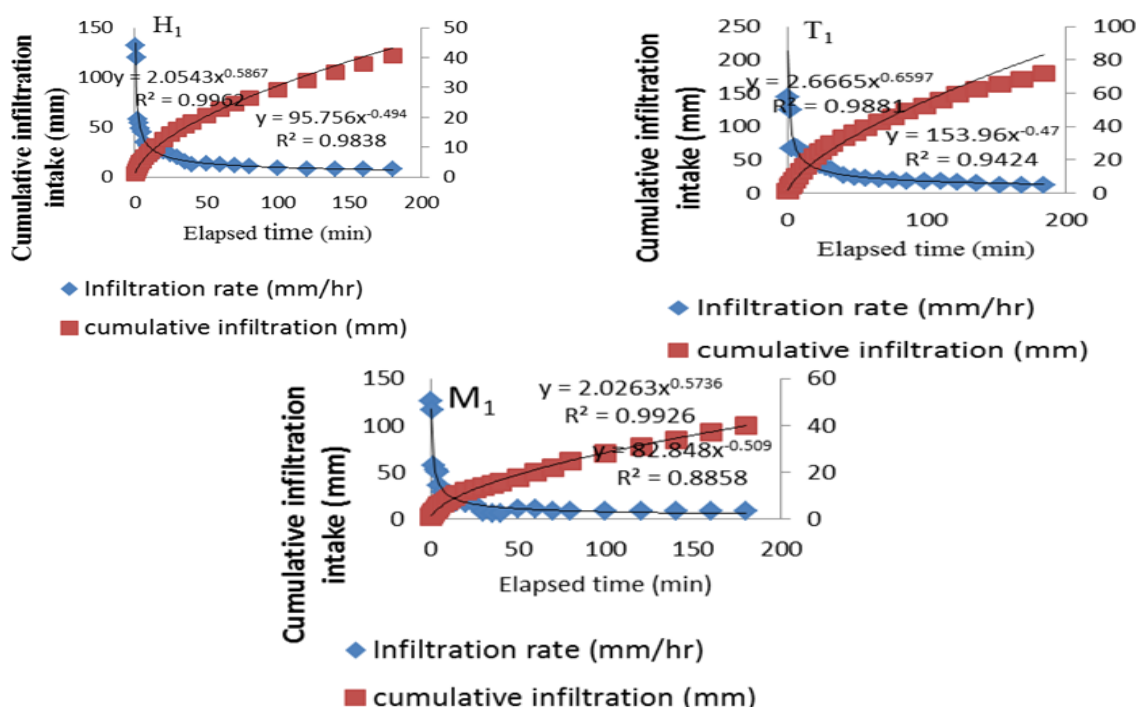
Figure 7. Cumulative infiltration (mm) and infiltration rate (mm/h) in the experimental plots.

The infiltration rate of soil in the irrigation scheme was determined for the three experimental plots by field measurement (Figure 7). The initial infiltration rate rapidly decreased as the soil was wetted, and infiltration reached the basic rate almost after 3 h. Basic infiltration rate determined for H1, M1, and T1 was 8.5, 9.0, and 11.25 mm/h, respectively. According to the Food and Agriculture Organization (2002), the recommended optimum infiltration rate for gravity irrigation is between 7 and 35 mm/h; for clay loam and loam this ranges between 5 and 10 mm/h, respectively. Hence, the basic infiltration rate for H1 and M1 was within the recommended range, while for T1 it was slightly higher. This may be due to land management conditions, because infiltration rate is markedly influenced by the condition of the soil surface. In regard to the ideal infiltration rate, the time for which irrigation water is applied must be properly managed to avoid deep percolation. At T1, due to furrow alignment, severe deep percolation was a problem that farmers did not take into account. The efficiency of irrigation application can be increased by using an
